Debris/Ice/TPS Assessment and Integrated Photographic Analysis of Shuttle Mission STS-111

Author Name: Armando Oliu

June 2005

June 5, 2002

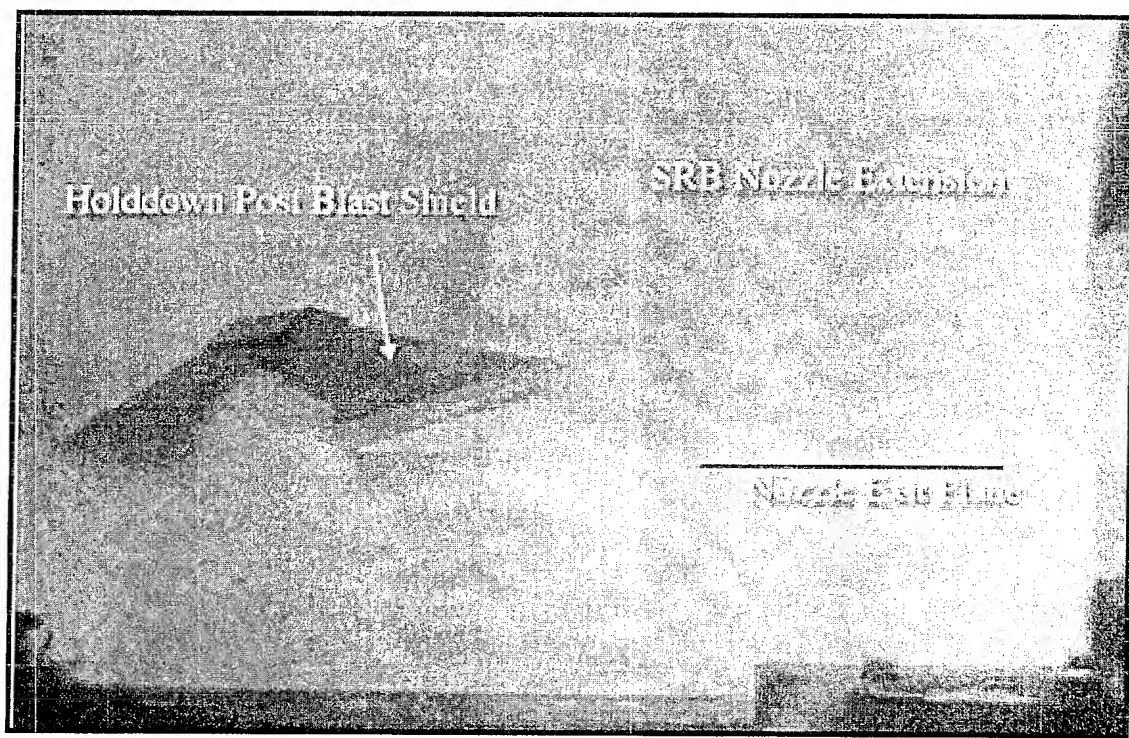
Figure 2.1 (C) Holddown Post Blast Shield Closes Late (Camera E10). Image Courtesy of Marshall Space Flight Center.

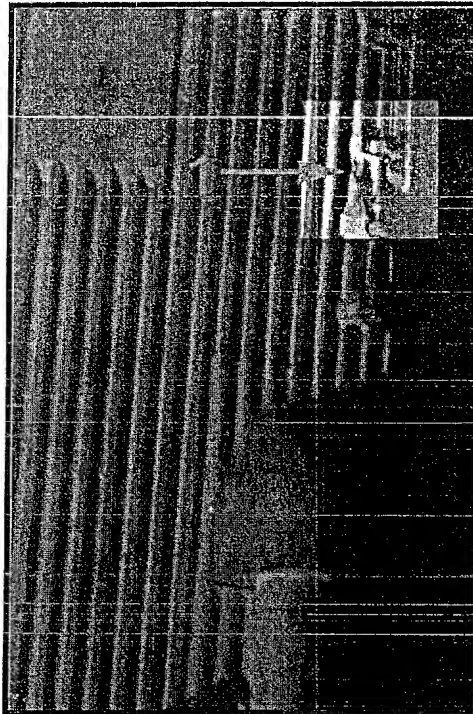
One small erosion mark was noted on an intertank stringer head near the forward end of the LO2 feedline in the -Y direction from the LO2 feedline bellows.

Figure 2.3.1 (B) 35mm Image of TPS Erosion on the ET Intertank (Frame 39)

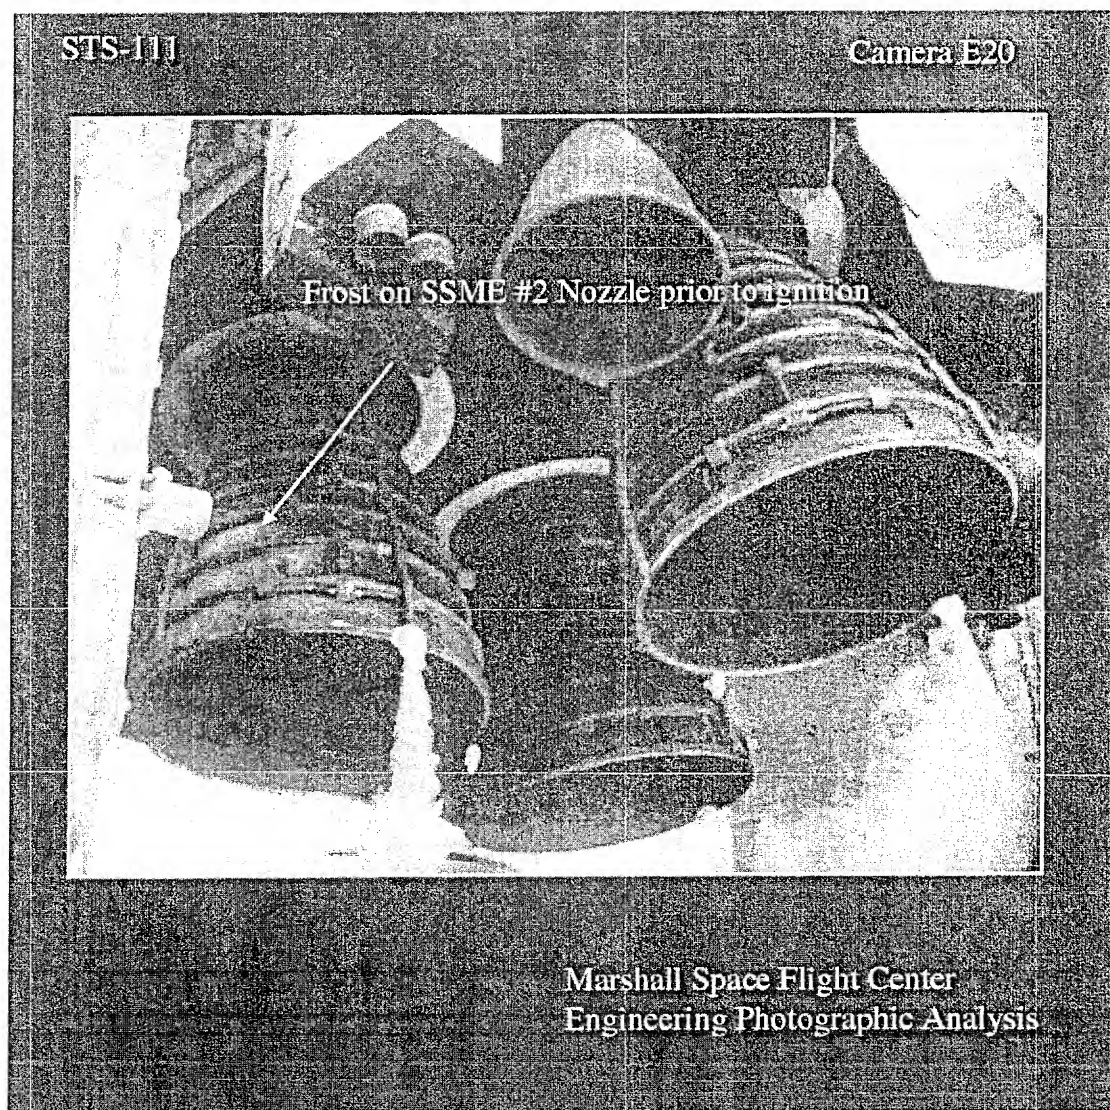
Frost was observed on SSME#2 Nozzle prior to SSME ignition.

Figure 11. E20: Frost on SSME#2 Nozzle Prior to Ignition

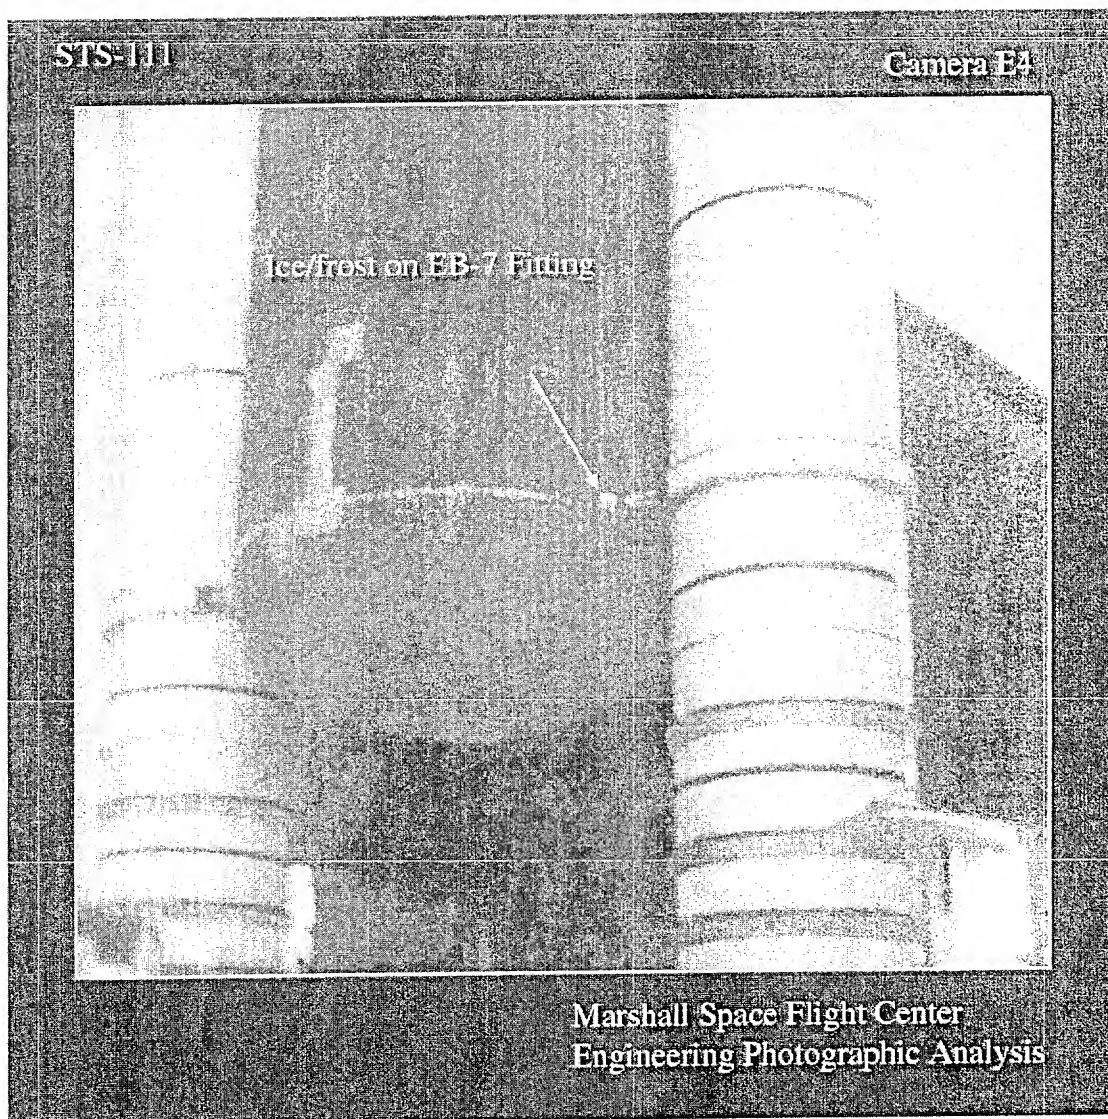
A light-colored area, indicative of ice or frost, at the EB-7 ET/SRB Aft Attach location was observed prior to liftoff.

Figure 14. E4: Ice/Frost on ET/SRB Aft Attach

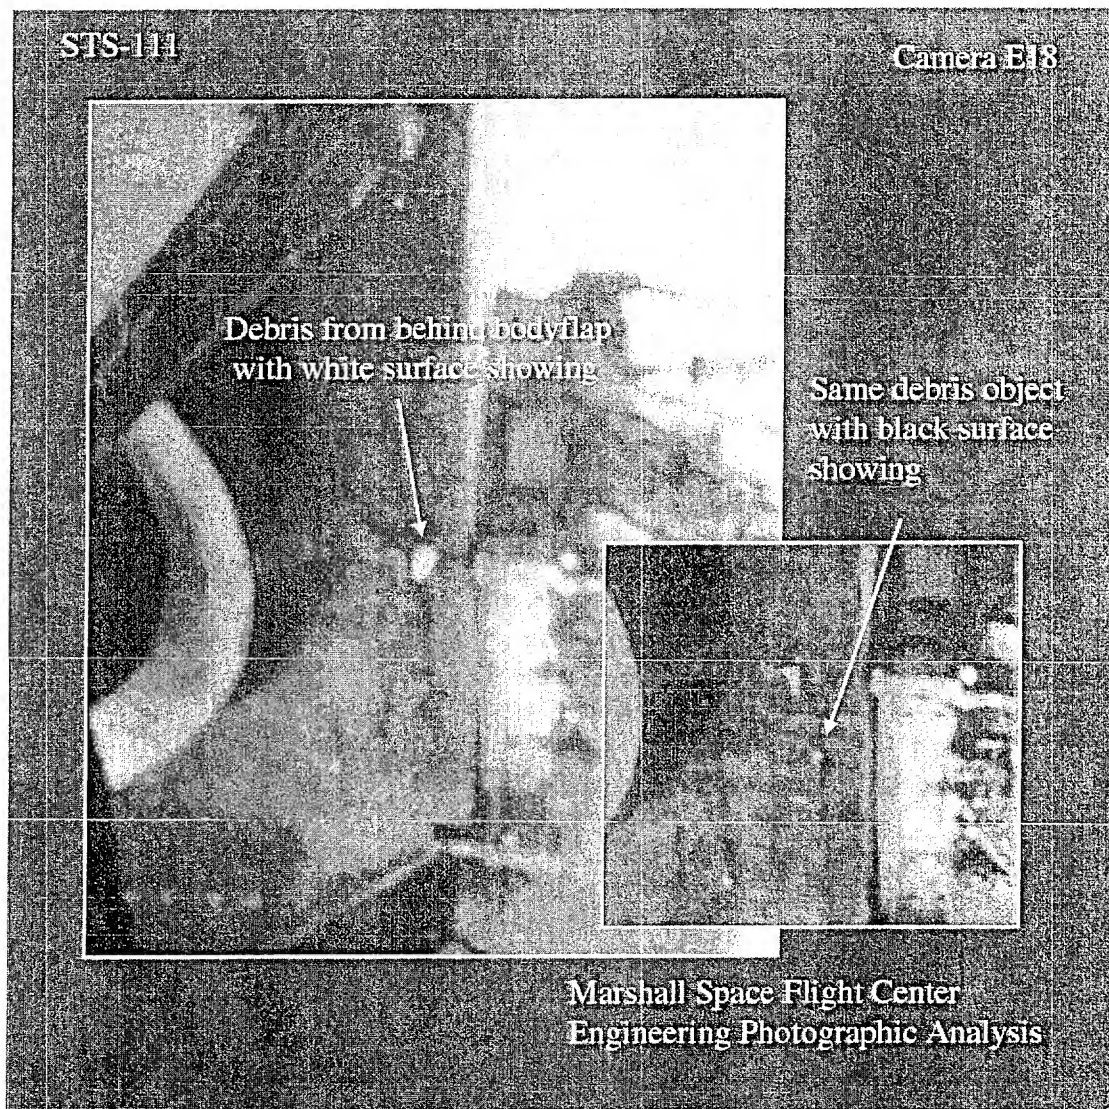
A debris object was observed forward of the +Y side of SSME#3 nozzle. The debris object was light colored on one side and dark colored on the opposing side, indicative of a chipped Orbiter tile. The images below were obtained between 156:21:22:46.155 and 156:21:22:46.218 UTC.

Figure 16. E18: Debris with White and Black Surface

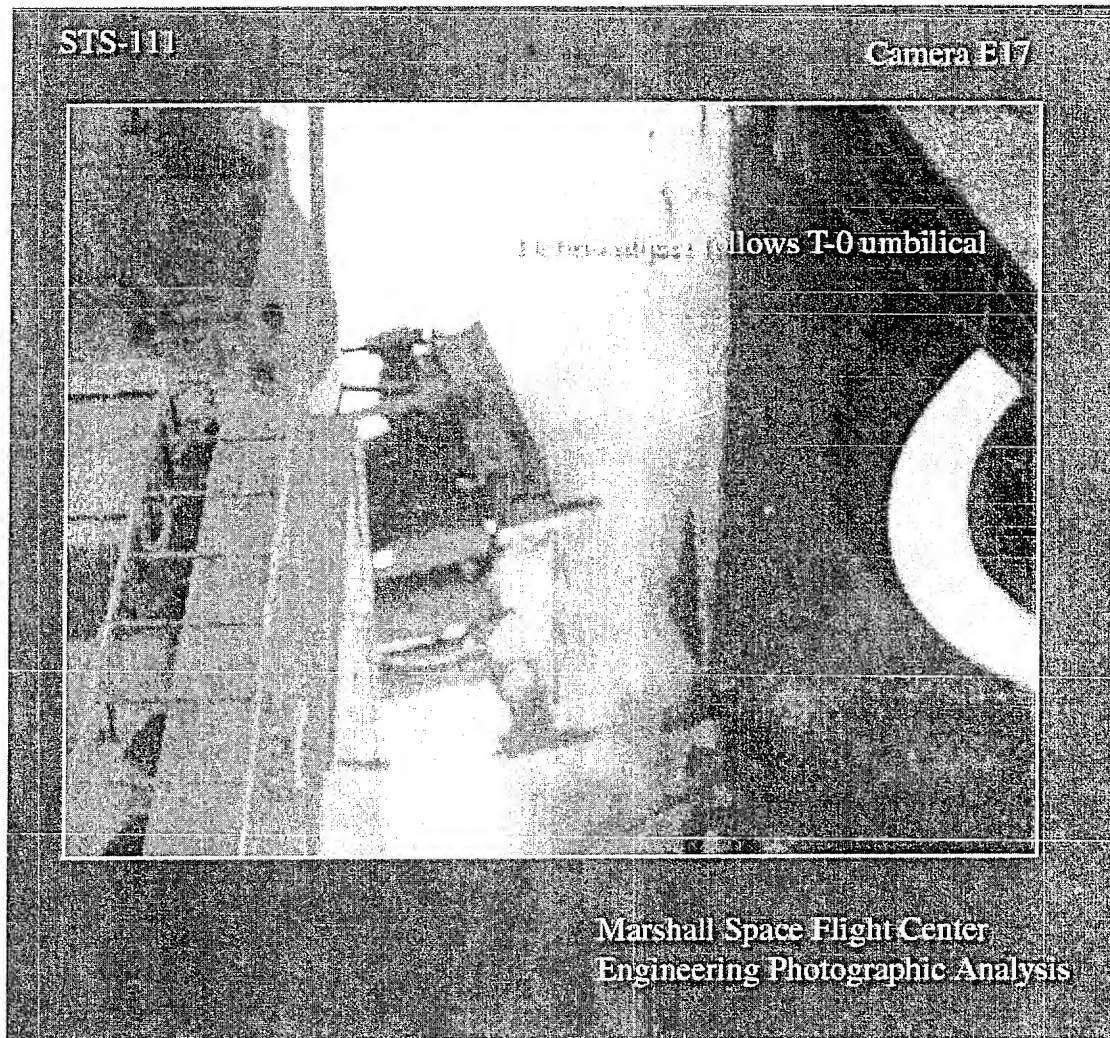
A dark object follows the T-0 umbilical toward LO2 Tail Service Mast during umbilical retraction. The object appears connected by wire to the umbilical assembly, but vapors surrounding the object make positive identification of an attached wire difficult. The image below was timed at 156:21:22:49.499 UTC.

Figure 17. E17: T-0 Umbilical Object

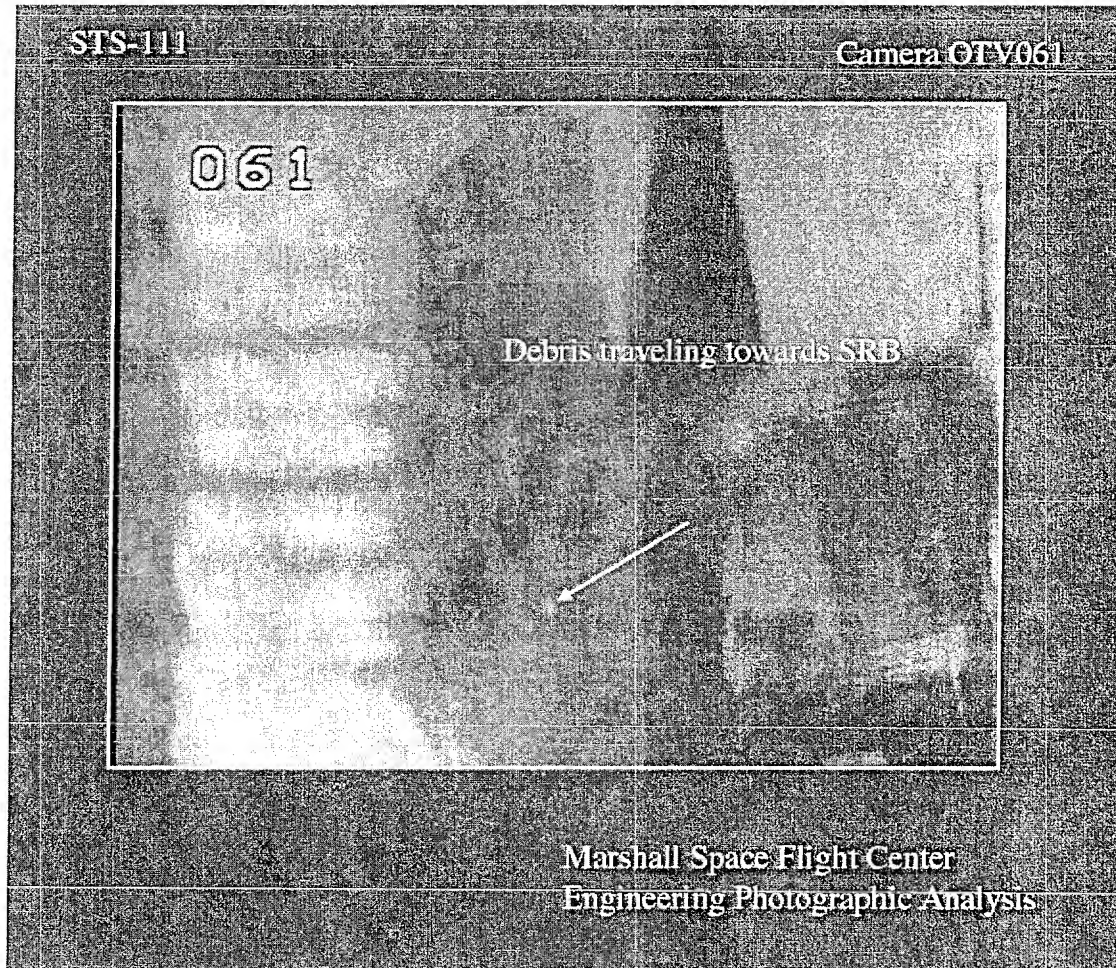
A light-colored debris object was observed traveling toward the LSRB just after liftoff.

Figure 19. OTV061: Debris Traveling Toward SRB

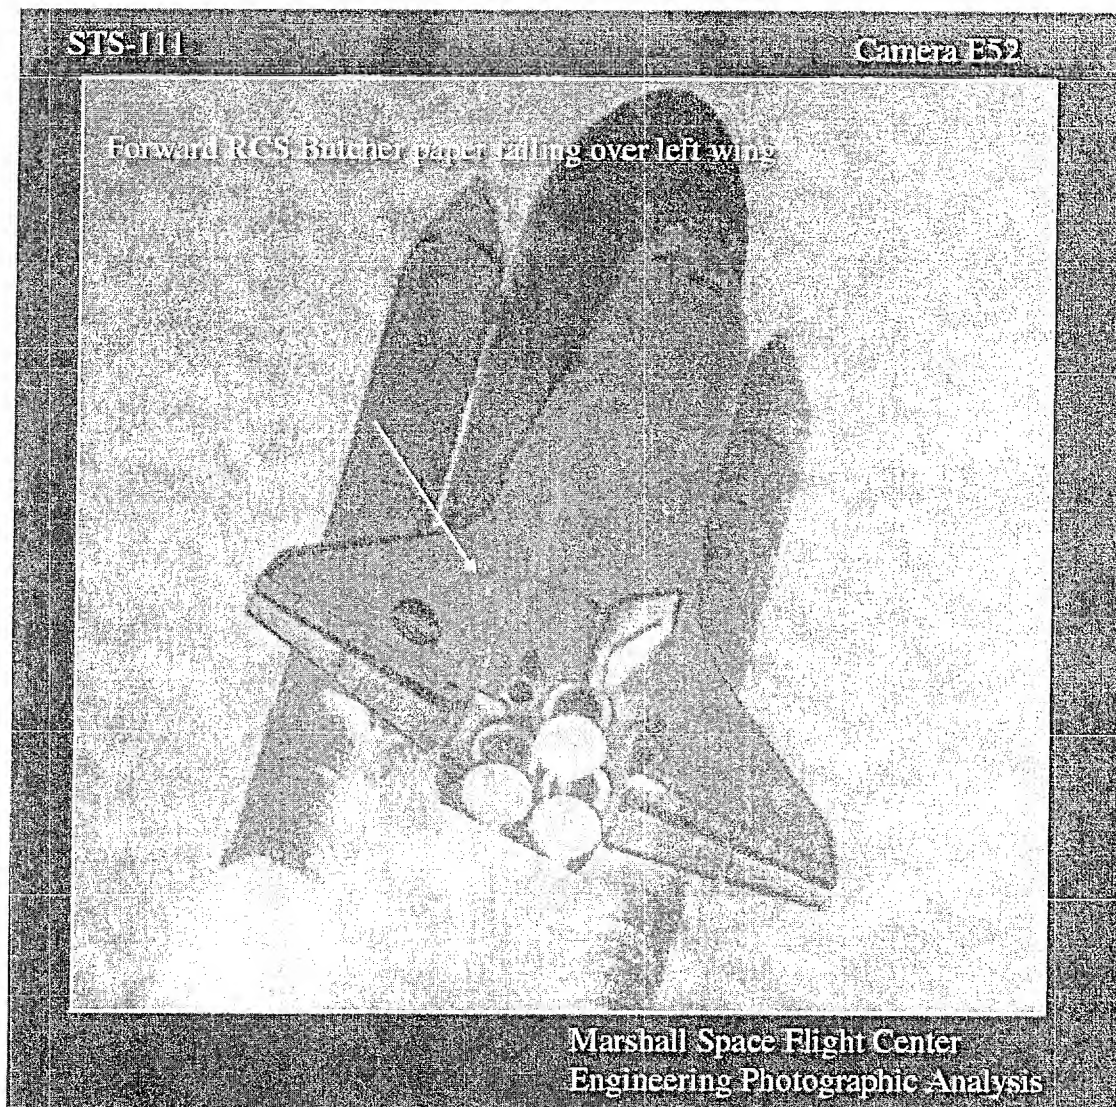
Forward RCS Butcher Paper was observed falling over the left wing of the Orbiter during ascent.

Figure 22. E52: Forward RCS Paper Falling Aft

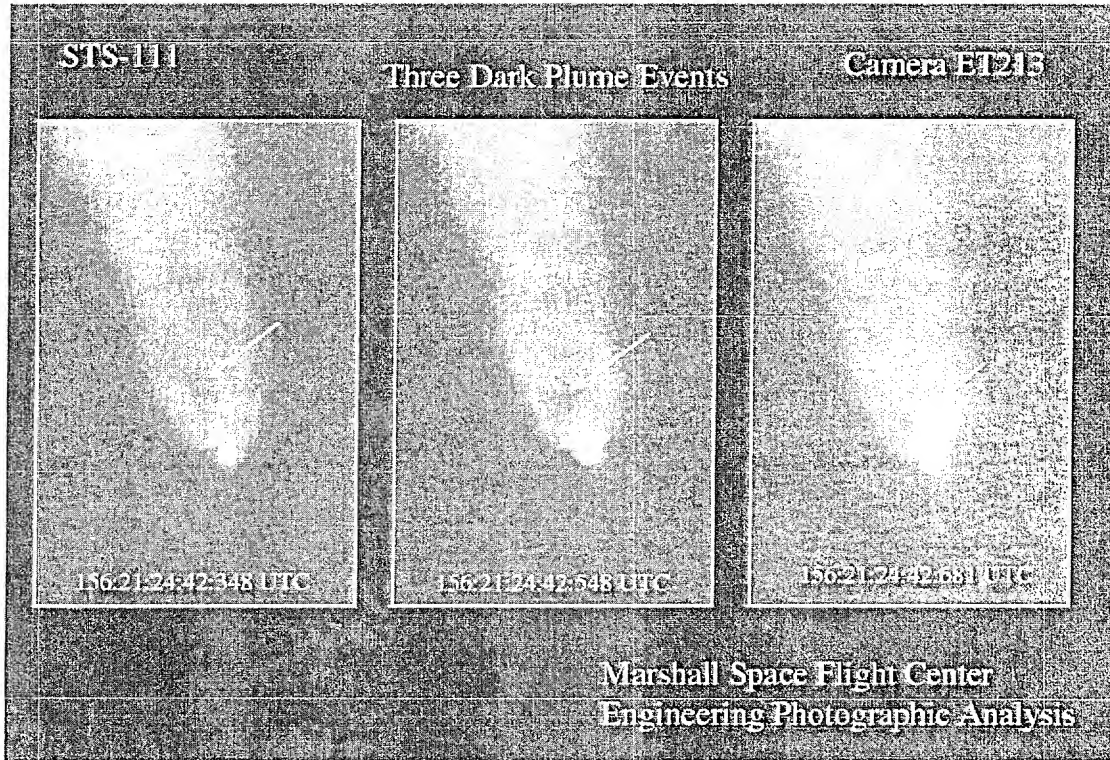
Three separate events in which dark areas appeared in the SRB plumes were observed. The events were timed at 156:21:24:42.348, 156:21:24:42.548, and 156:21:24:42.681 UTC.

Figure 31. ET213: Dark Plume Events

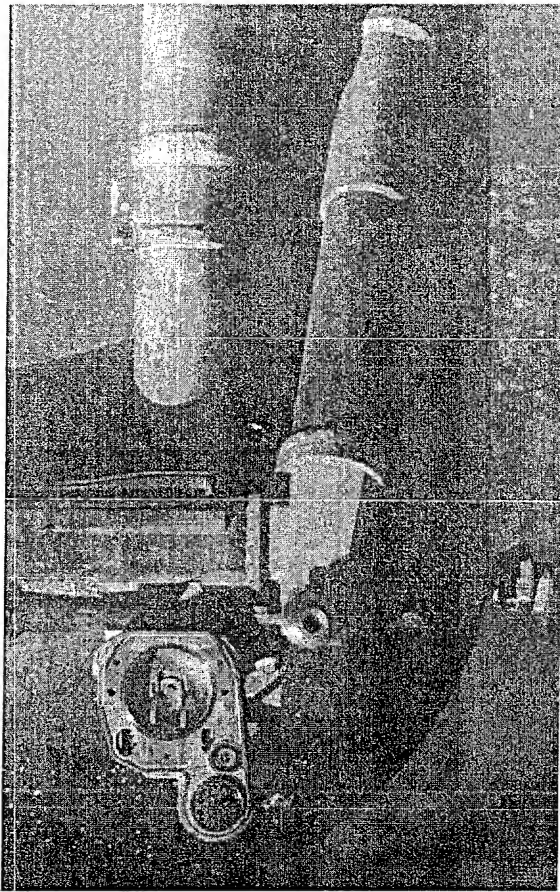
Figure 38. UMB35mm: Frame 12

TPS loss was typical. Normal popcorning and divoting of the aft dome, Figure 38. Typical TPS missing from thrust strut and LO2 feedline, Figure 38 and Figure 39. Divot noted on thrust strut, Figure 38. Three small divots noted, two under and one on the +Y side, near the bipod, Figure 41. One divot on intertank noted near forward -Y side of the LO2 feedline, Figure 43. Nosecap appeared nominal, Figure 44. The purge seal was noted in place around the EO3 joint, Figure 38. Glare from within EO3 joint bore observed, probably a reflection from the chamfer of EO3 bolt, Figure 38. A small positive yaw angle noted as ET moves away from Orbiter is noticeable through the sequence of frames.
